Manhole Inspection Summary

Manhole # S31CC1007MH

Insp Date: **10/9/08 1:14 PM**

Location Address: **SAN MARTIN DR**

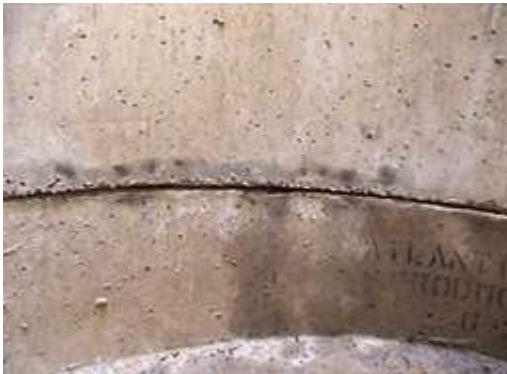
Defect

Bench ☒ Exists Material: **Brick** ☐ Parged ☒ **Debris** (not Condition related)
Condition: ☒ Sound ☐ Cracked ☐ Root Intrusion ☐ Deteriorated ☐ Leaks ☐ Debris

Surcharge ☒ **Evidence Of Surcharge** Depth: **1** (ft.) ☐ Active Surcharge Present

Evidence of surcharge - Bench debris.

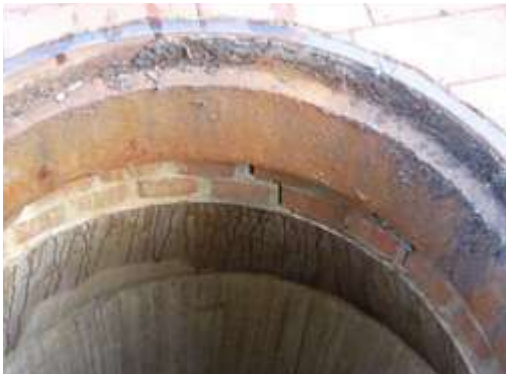
Defect

Barrel Material: **Precast Concrete** ☐ Parged
Shape: **Circular** Diameter: **42** (in.) Length: (in.)
Condition: ☒ Sound ☐ Cracked ☐ Root Intrusion ☐ Loose Brick ☐ Deteriorated
Infiltration: ☐ None ☒ **Joint** ☐ Cracks ☐ Mortar ☐ Roots ☐ Wall

Barrel infiltration.

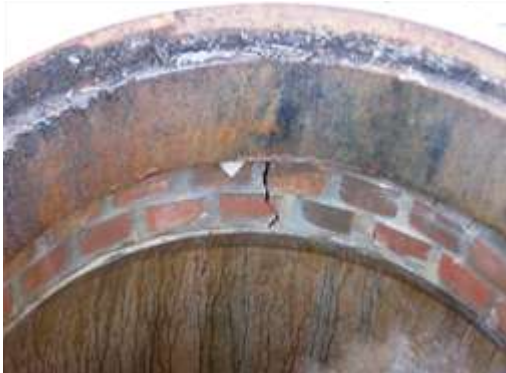
Defect

Frame Offset: **0** (in.) Condition: ☐ Sound ☐ Cracked ☒ **Leaks**

Chimney / Frame Adjustment ☒ Exists Material: **Brick** ☐ Parged Height: **7** (in.)
Condition: ☐ Sound ☒ **Cracked** ☐ Root Intrusion ☐ Loose Brick ☐ Deteriorated
Infiltration: ☐ None ☒ **Joint** ☒ **Cracks** ☐ Mortar ☐ Roots ☐ Wall

Corbel Material: **Precast Concrete** ☐ Parged Type: **Concentric/Eccentric**
Condition: ☒ Sound ☐ Cracked ☐ Root Intrusion ☐ Loose Brick ☐ Deteriorated
Infiltration: ☐ None ☒ **Joint** ☐ Cracks ☐ Mortar ☐ Roots ☐ Wall

Frame leaks. Adjustment cracks and infiltration. Corbel infiltration - other side.

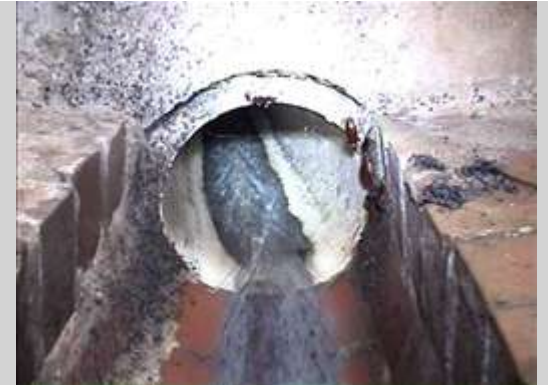
8 in. Circular Gravity Sewer Pipe Out @ 12 O'Clock

Pipe Material: **Unknown** ☒ Pipe Lined

Invert Depth: **9.90** (ft.) Flow Characteristics: **Fast**

Infiltration: **None** Pipe Seal Cond: **Sound**

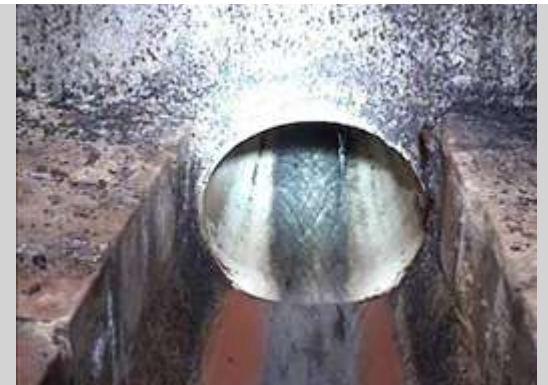
8 in. Circular Gravity Sewer Pipe In @ 7 O'Clock

Pipe Material: **Unknown** ☒ Pipe Lined

Invert Depth: **9.73** (ft.) Flow Characteristics: **Fast**

Infiltration: **None** Pipe Seal Cond: **Unknown**
